# QUAS-ANIMAL

**Resurrecting a 206cc Intek  
for Performance**

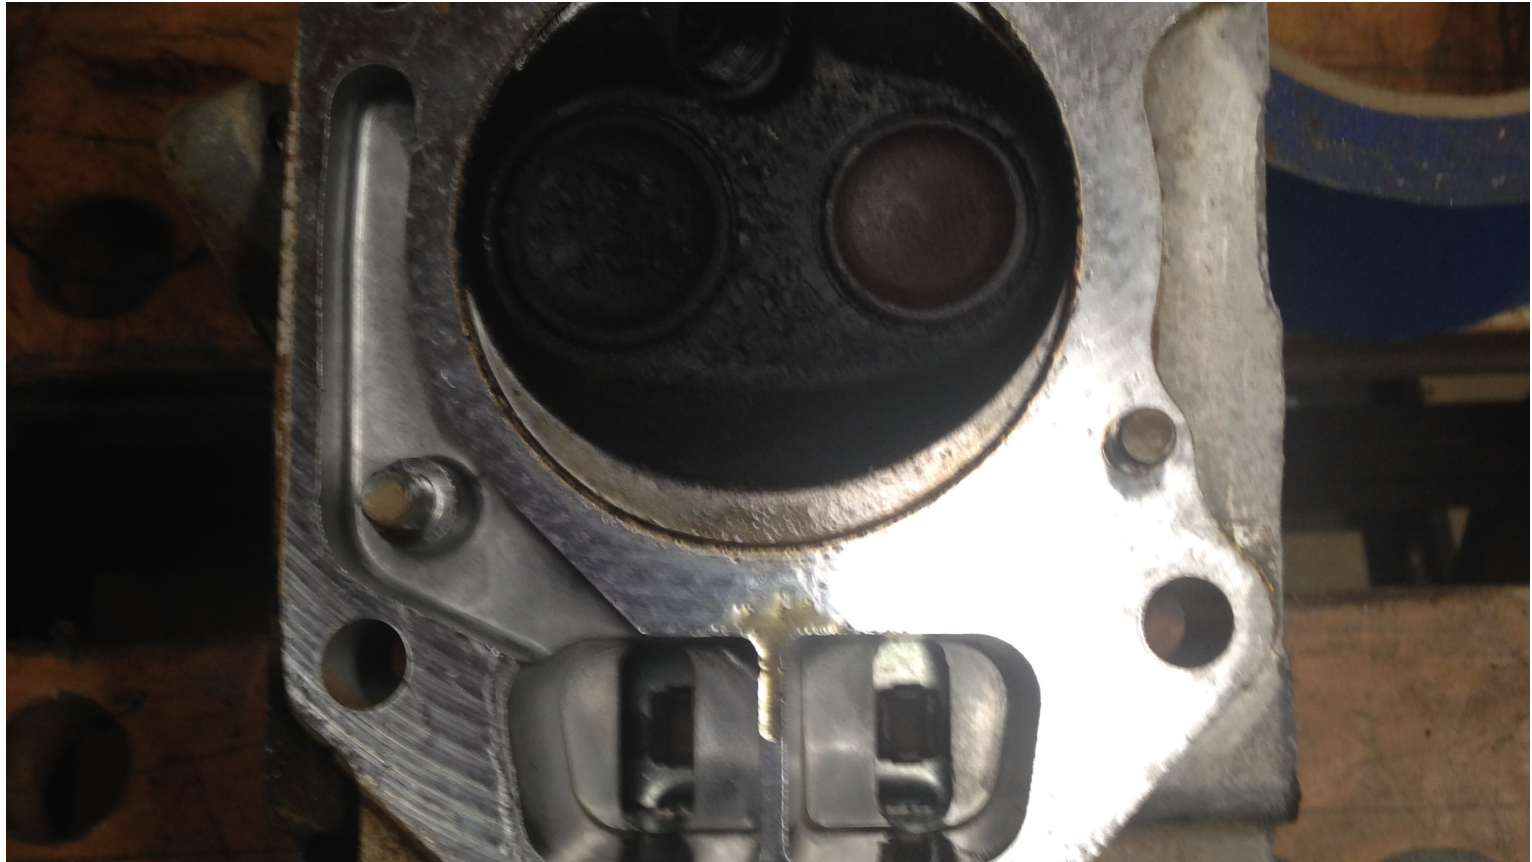
# Combustion Chamber Fairly Clean

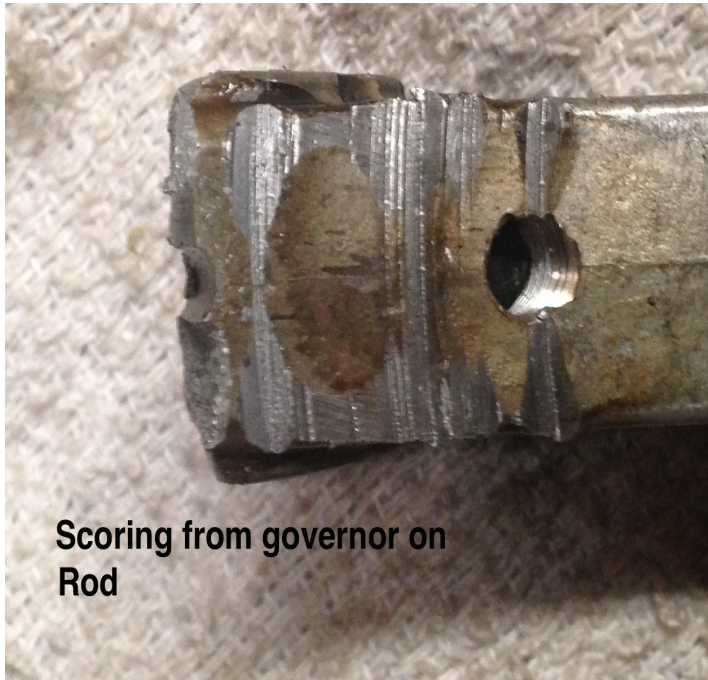
# Piston Rod Shattered and Scored

Scoring from governor on  
Rod

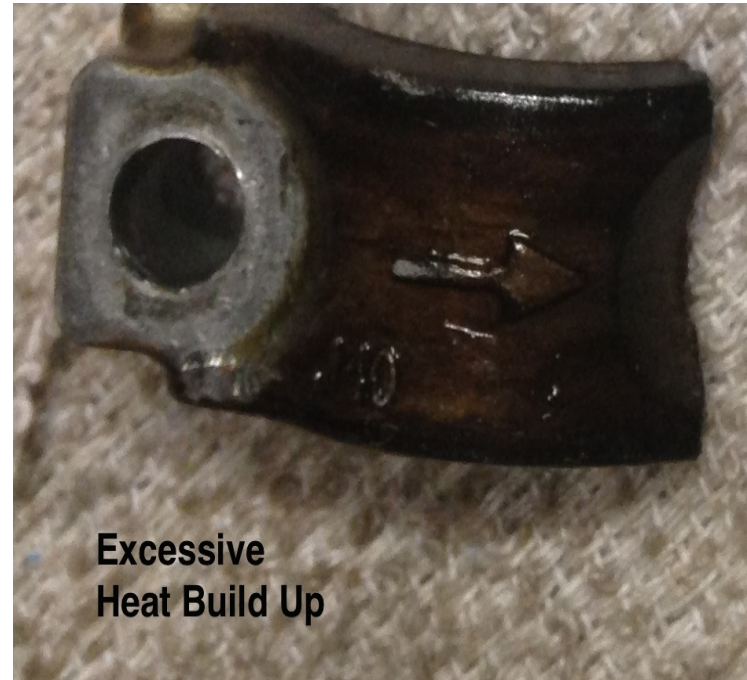
Excessive  
Heat Build Up

Governor seems to have broken loose and scored rod over time. Rod cap overheated before breaking.

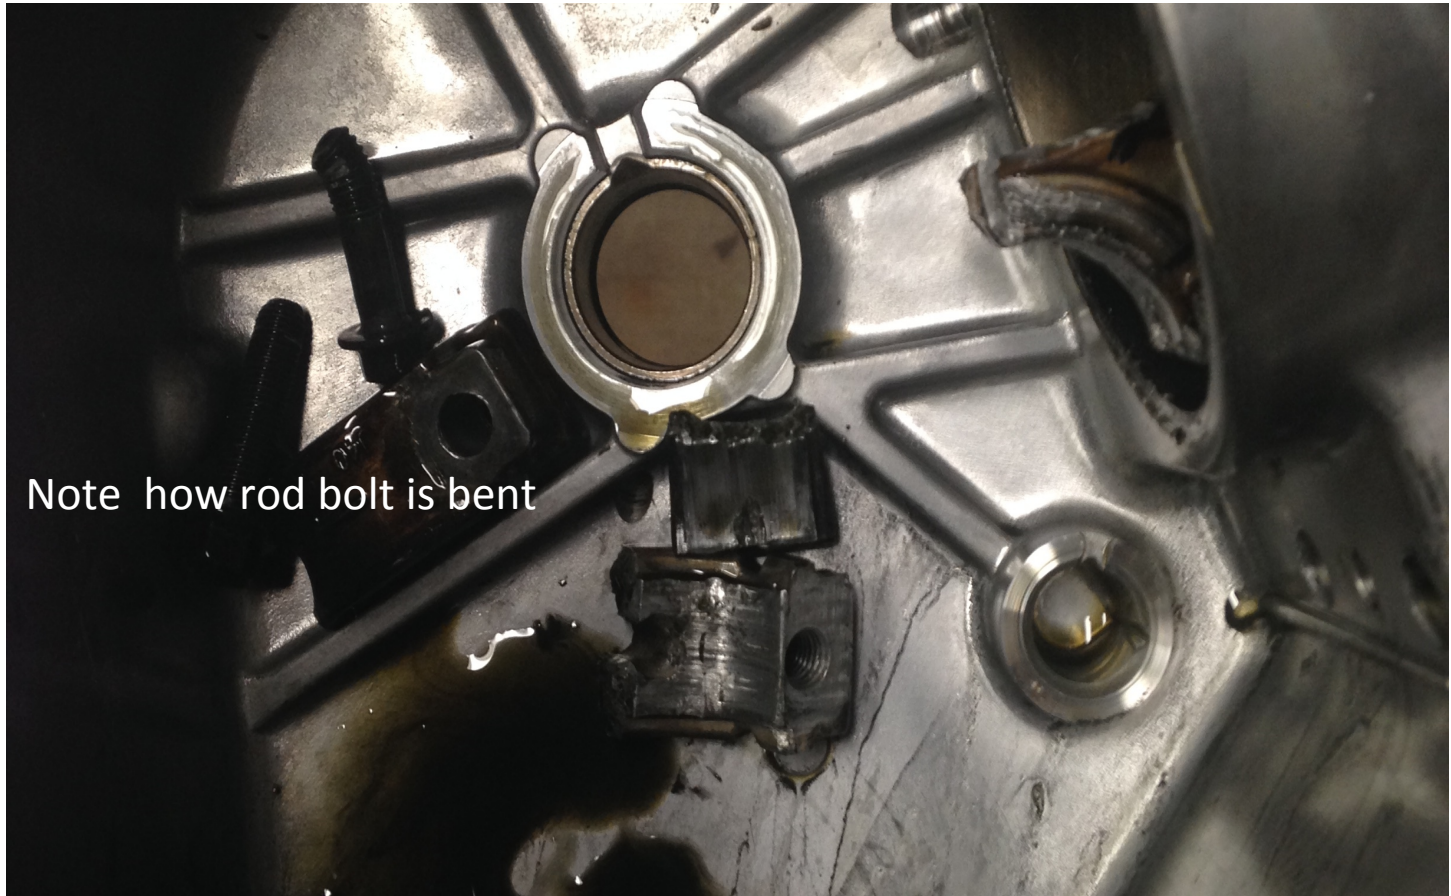
# Rod Shattered at Crank

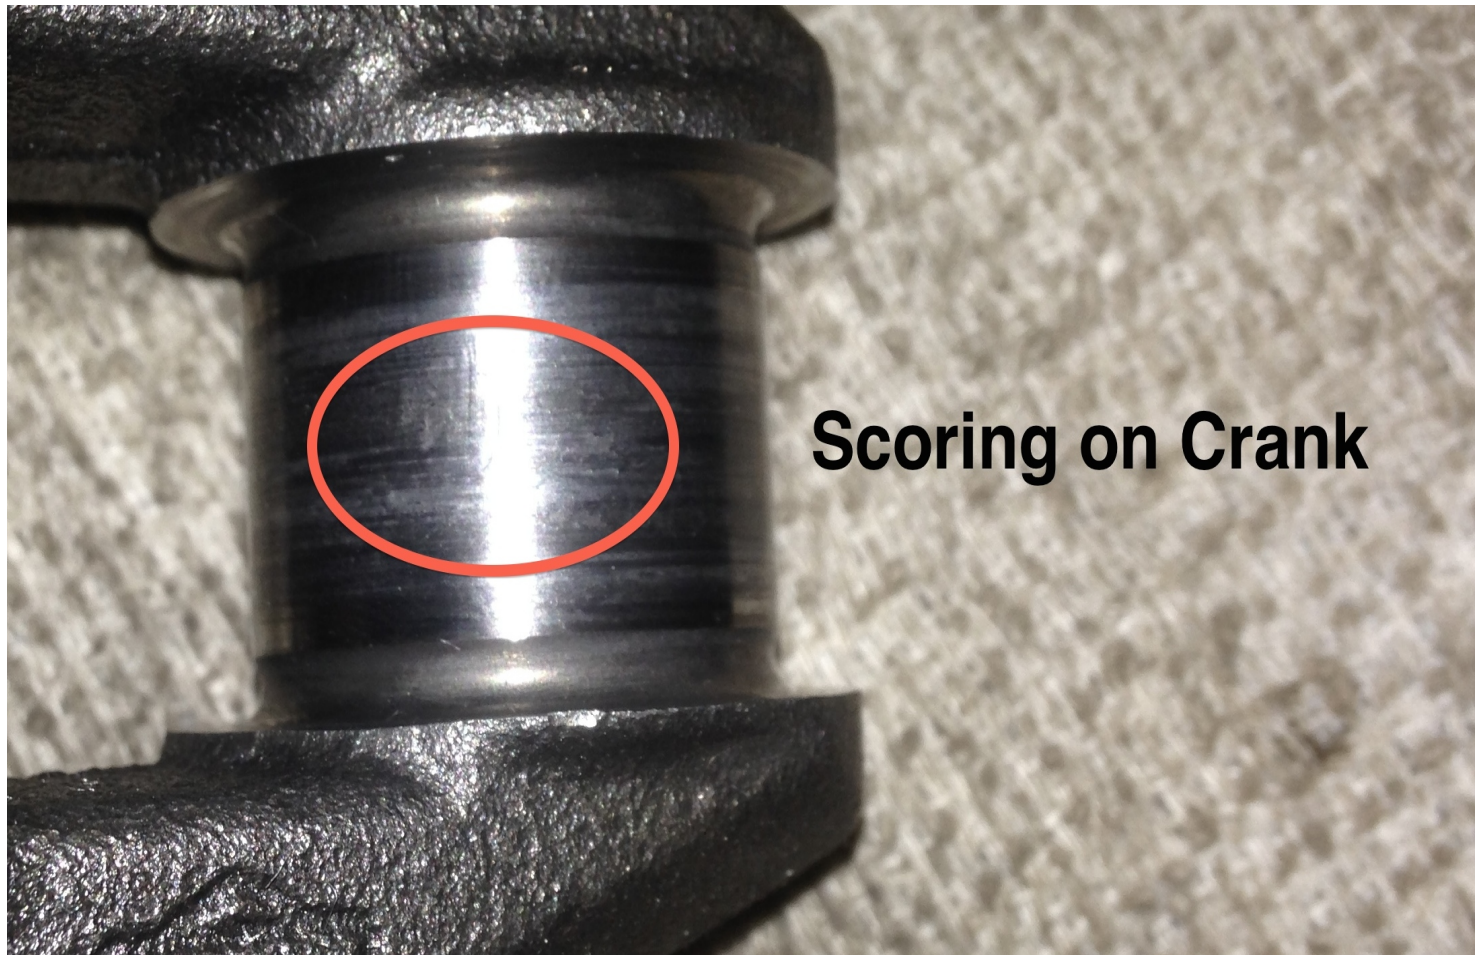
# Crank Main Journal Scoring

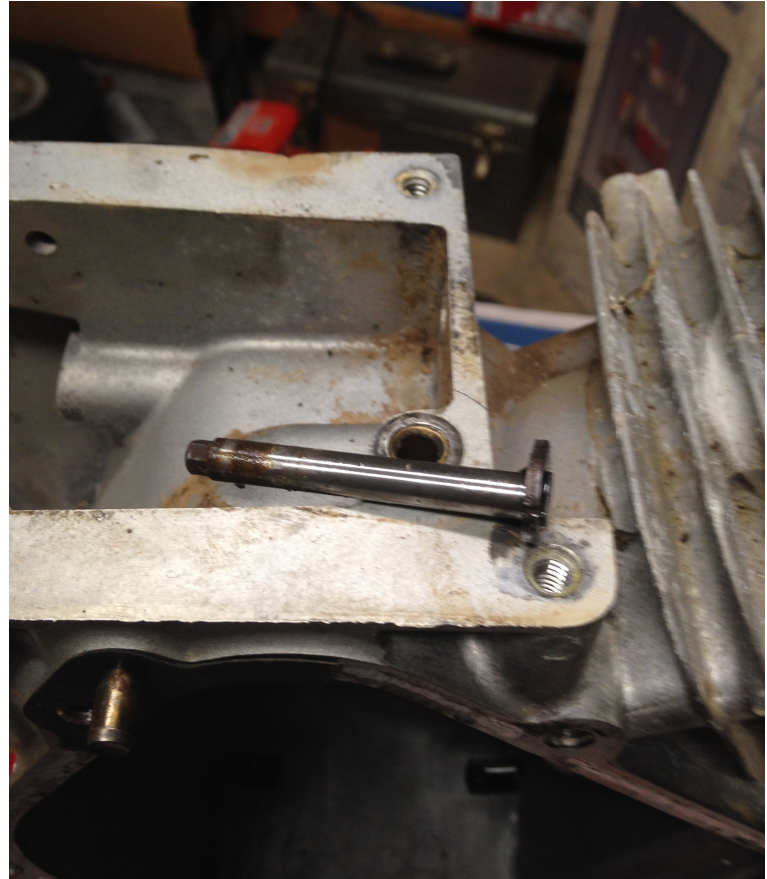
## Governor Removal

The governor consists of three (3) parts. An idler gear from the cam shaft, the main spool with flyweights and the rod which exits the block at the top of the case. The rod is located in a brass bearing. The rod is secured by a press fitting, and is removed. The rod can be driven through the bearing and removed.

The idler gear and main spool are on shafts above the crankshaft and is driven by a gear on the crankshaft. These are held in place with c-clips. On this engine, the spool c-clip had broken and the flyweights interfered with the connecting rod, causing rod failure.

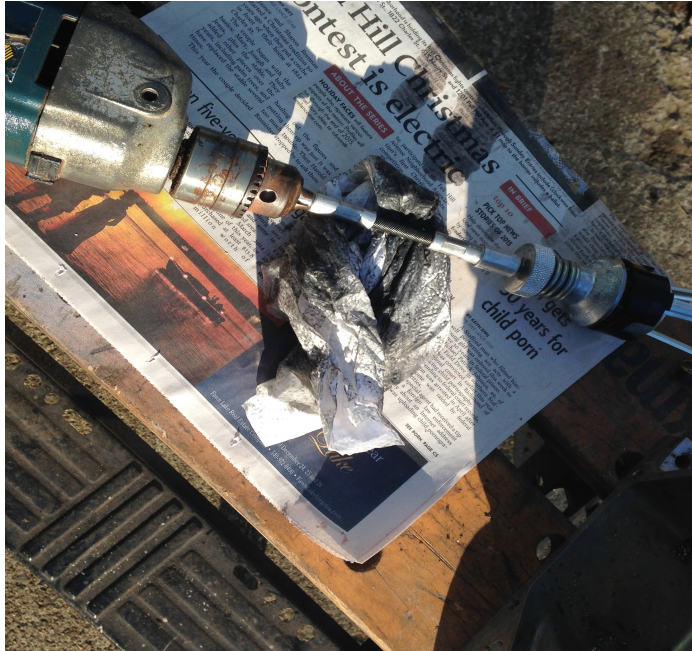
# Honing the Cylinder

Cylinder had good amount of glaze. Cutting oil and cylinder hone used to remove build-up and restore crosshatch.
